Roofing

Shiner Roofing, Siding and Windows recently completed a project in Vienna, Virginia that we would like to show you. Originally built in 1904, this property was formerly home to Beulah Methodist Church. For this project we performed a complete roof replacement for the entire main house and carriage house structures. We replaced the metal roof on the main house and shingle roof on the carriage house with new metal roofs, to achieve visual continuity between the two buildings.

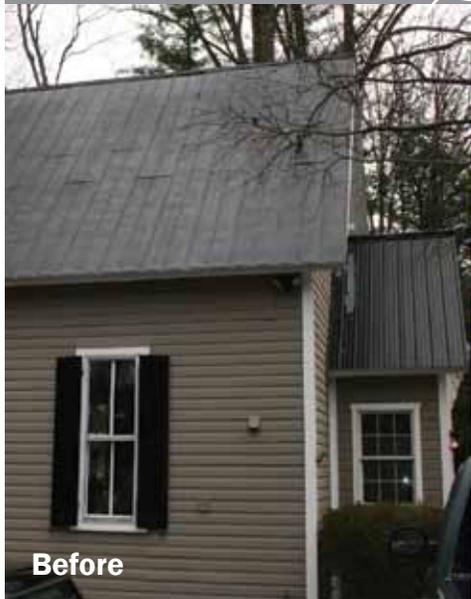
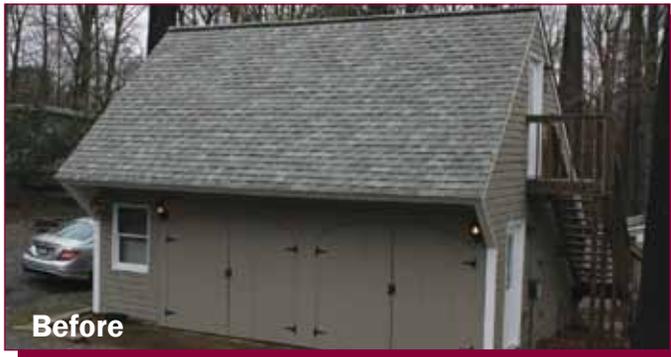
Before

We began the project by removing the existing layers of old asphalt shingles and underlayment down to the substrate on the carriage house. On the main house, one layer of metal roofing was removed, and all old roofing material was removed in sections for overnight rain protection. We repaired the existing roof deck as needed. We then installed sand-surfaced Winterguard membrane along all eaves, in all valleys, and at the base of all penetrations and roof wall intersections.

A custom-fabricated, painted aluminum drip edge was installed along the gutter line, followed by new underlayment over the roof deck. The new Kynar Coated Galvanized Standing Seam Steel roof was then installed per the manufacturer's specifications. The installation was completed with new Pro-Flash painted aluminum exhaust vent covers, custom aluminum painted flashing, and custom accessory hip and ridge caps.

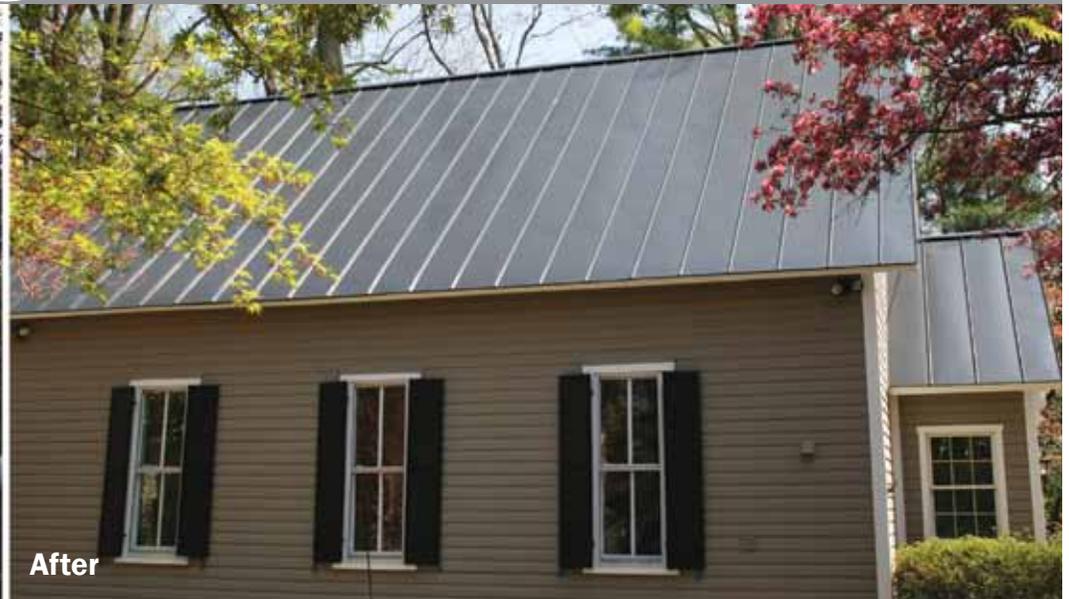
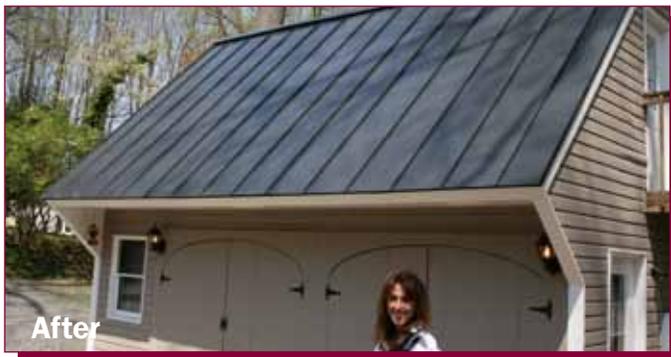
After
